Stage 2 Research Report of the 2019 Last Schooners Project  
The two-masted schooner *Katie Eccles* and three-masted schooner *Oliver Mowat*

Prince Edward County, Ontario

**Stage 2 Research Report of the 2019 Last Schooners Project:  
The two-masted schooner *Katie Eccles* and three-masted schooner *Oliver Mowat***

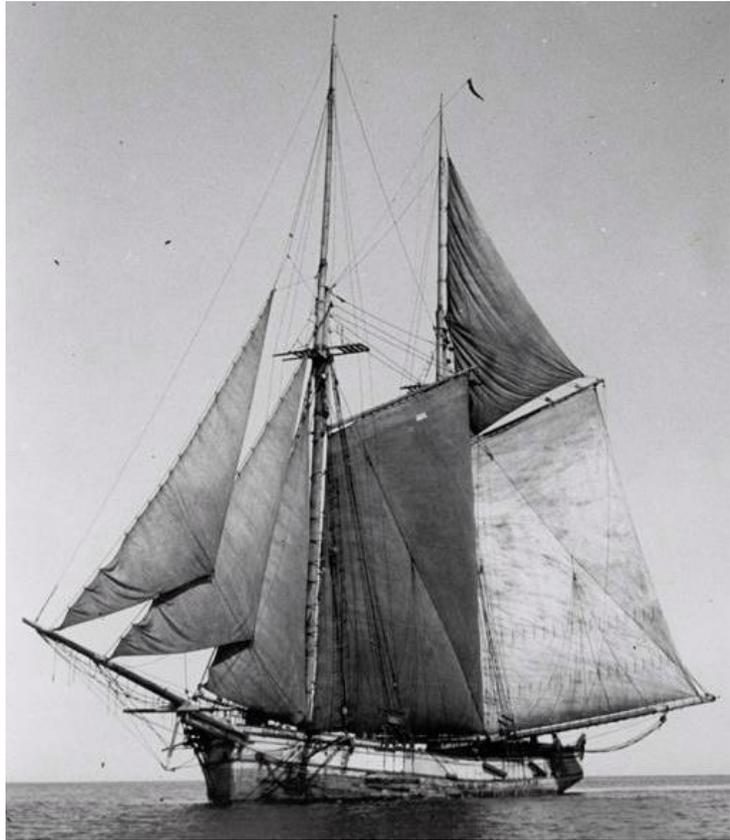
Figure 2. The *Katie Eccles* under sail at an unknown date (Digital/print image from the Fr. Edward J. Dowling, S.J. Marine Historical Collection, University of Detroit Mercy).

The martingale tapered along its length, widening upwards to form a set of jaws fitted to the lower side of the jib boom where it was fastened against the head of the bowsprit (Fig. 2). No measurements could be obtained for the spreader or martingale spars.

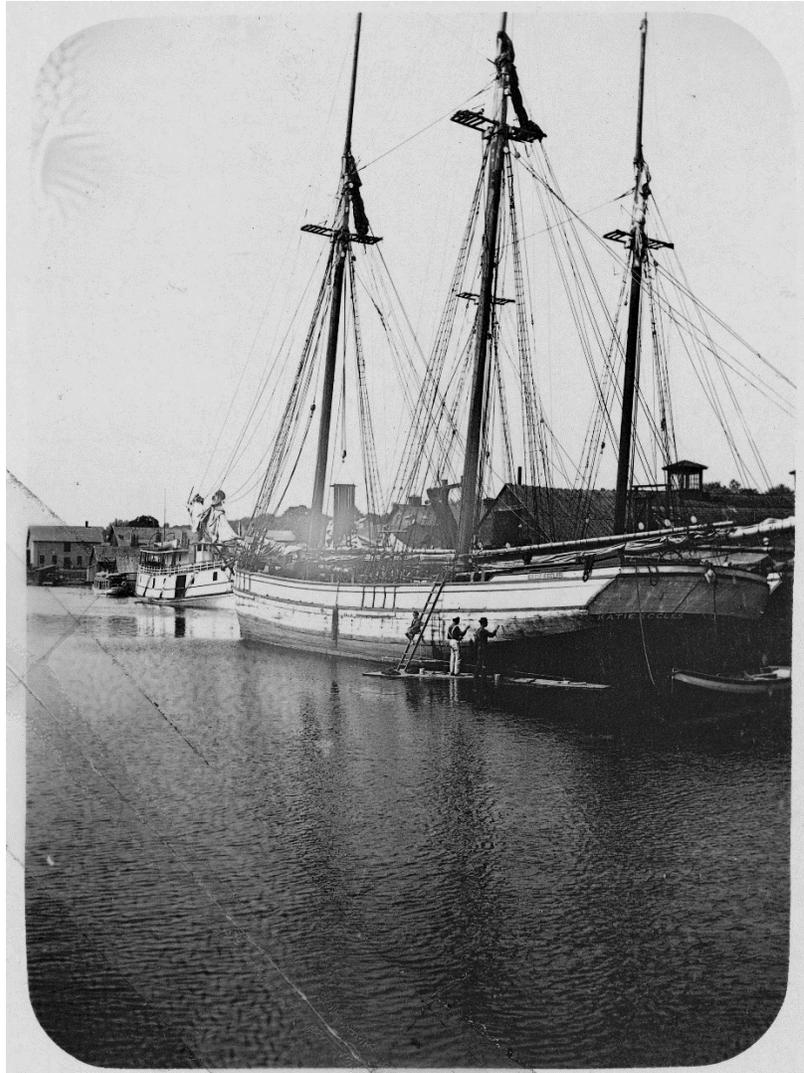
Figure 3. *Katie Eccles* being repainted at Napanee in 1900 (N-1551 –Transportation, schooner *Katie Eccles*, Napanee [1900] – LAHS Collection, Lennox & Addington County Museum, and Archives)

Forward of the fore hatch, the deck, particularly on the port side, is covered by tangled standing rigging which is draped over the port rail between the port fore chains and the cathead. Arrayed along the foredeck, from fore to aft, are the pawl post, windlass, and a considerable amount of chain piled on deck. Though the forecastle companionway hatch remains, the companionway, visible in historic photographs, has not been preserved (Figs.3, 13).

The forecastle companionway, visible in one historical photograph (Figs. 3, 13), has not been preserved. The companionway had a roof sloping downward forward, with a slight camber to the roof, the sides curving down and overhanging the sides of the companionway. A ladder remains fastened to the after beam of the forecastle hatch, allowing access to the compartment below. The positioning of the foremast hole, centered 17 ft. 6 in. (5.33 m) along the baseline, necessitated the placement of the mast partner beams immediately forward and aft of the mast.

Between these rail stringers and the covering board, the bulwarks were planked with seven narrow strakes. Five small scuppers were cut into the lower strake amidships with five more along the main chains. A narrow gap between the lower bulwark planks and the covering board is apparent in historical photographs (Fig.3).

Two sheer rails were fastened to the fore shrouds above the deadeyes and immediately above the port and starboard running lights. These running lights, the backboards of which have not been preserved had Fresnel-lens lanterns set against a backboard, which were lashed to the shrouds. Two Fresnel lenses, presumably from these lights, are present among the artifact assemblage on the port side of the deck immediately forward of the great beam. Three rails were lashed to the shrouds in place of ratlines as the shrouds narrowed at the hounds (Fig.3).

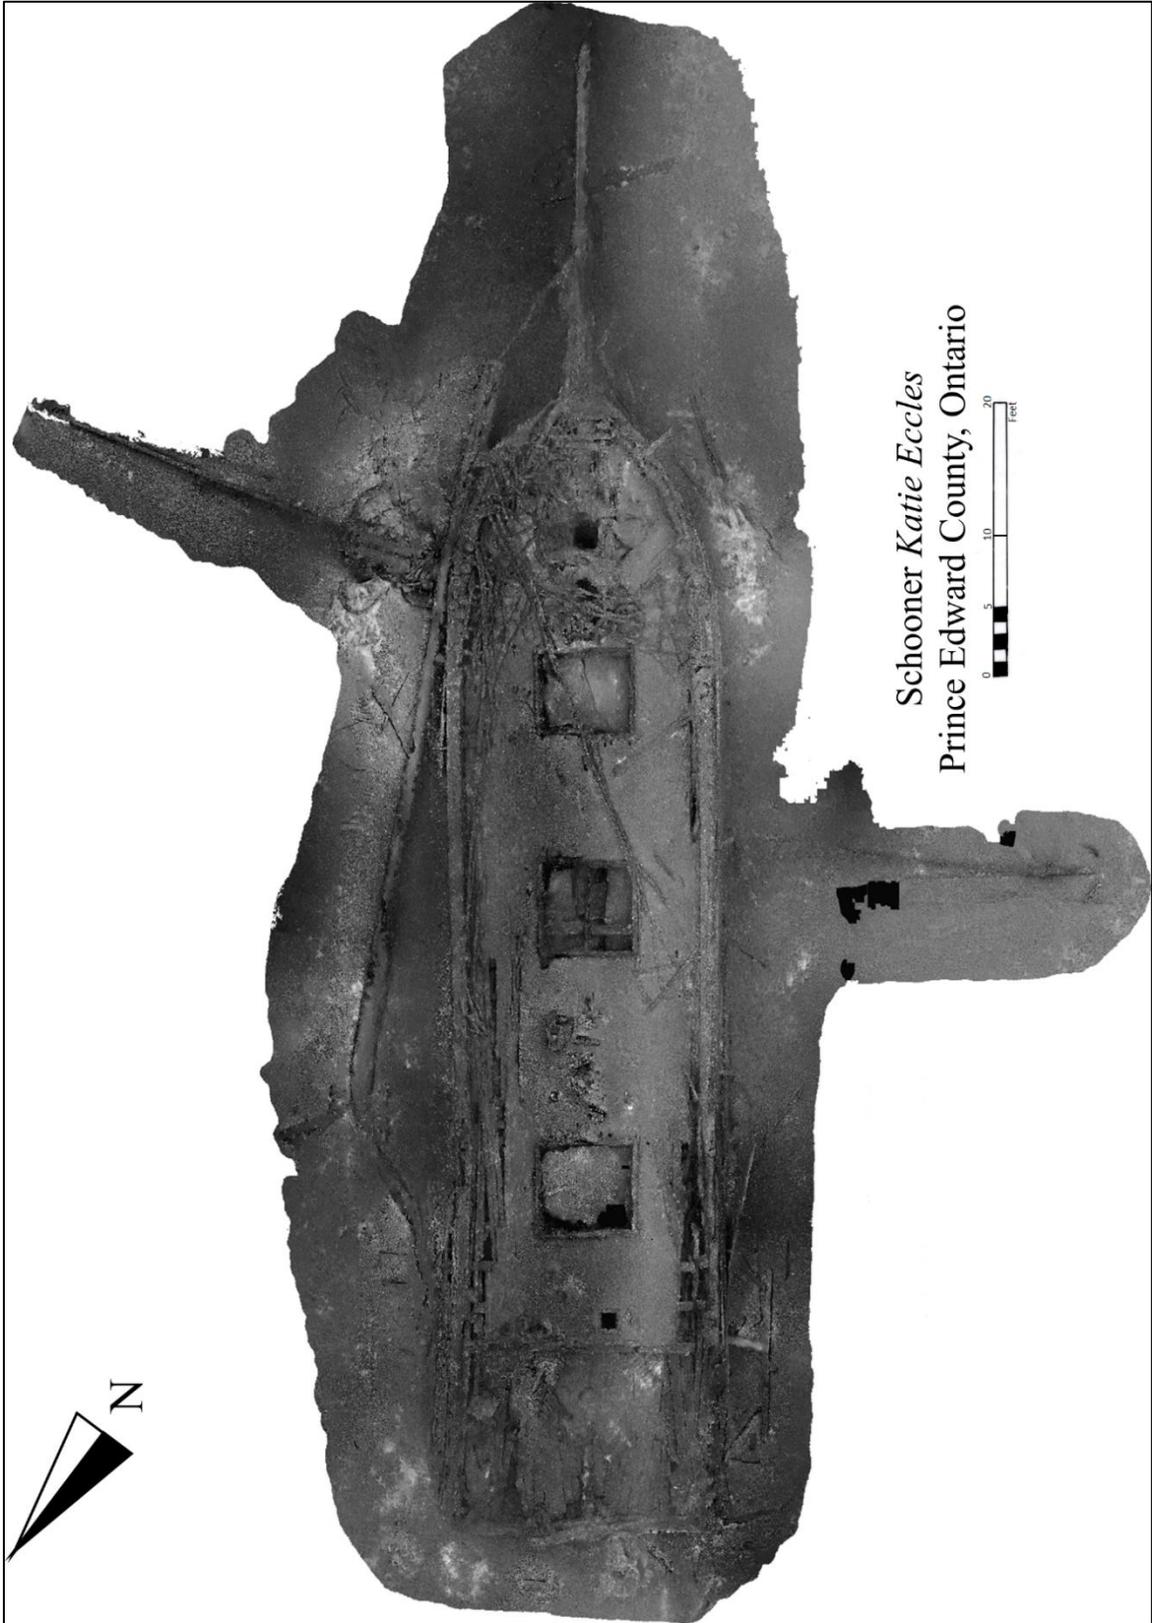
Figure 4. Site Orthophoto of the *Katie Eccles*

The *Eccles'* hull is intact for approximately two-thirds of its length. From the bow to midships at the mainmast, disruption of the hull is limited to disarticulation of some deck planking and damage to the bulwarks between the port fore chains and amidships, and at the starboard bow between the starboard hawse pipe and the starboard chock bits. The starboard chock and cap rail have been detached forward of the cathead to starboard.

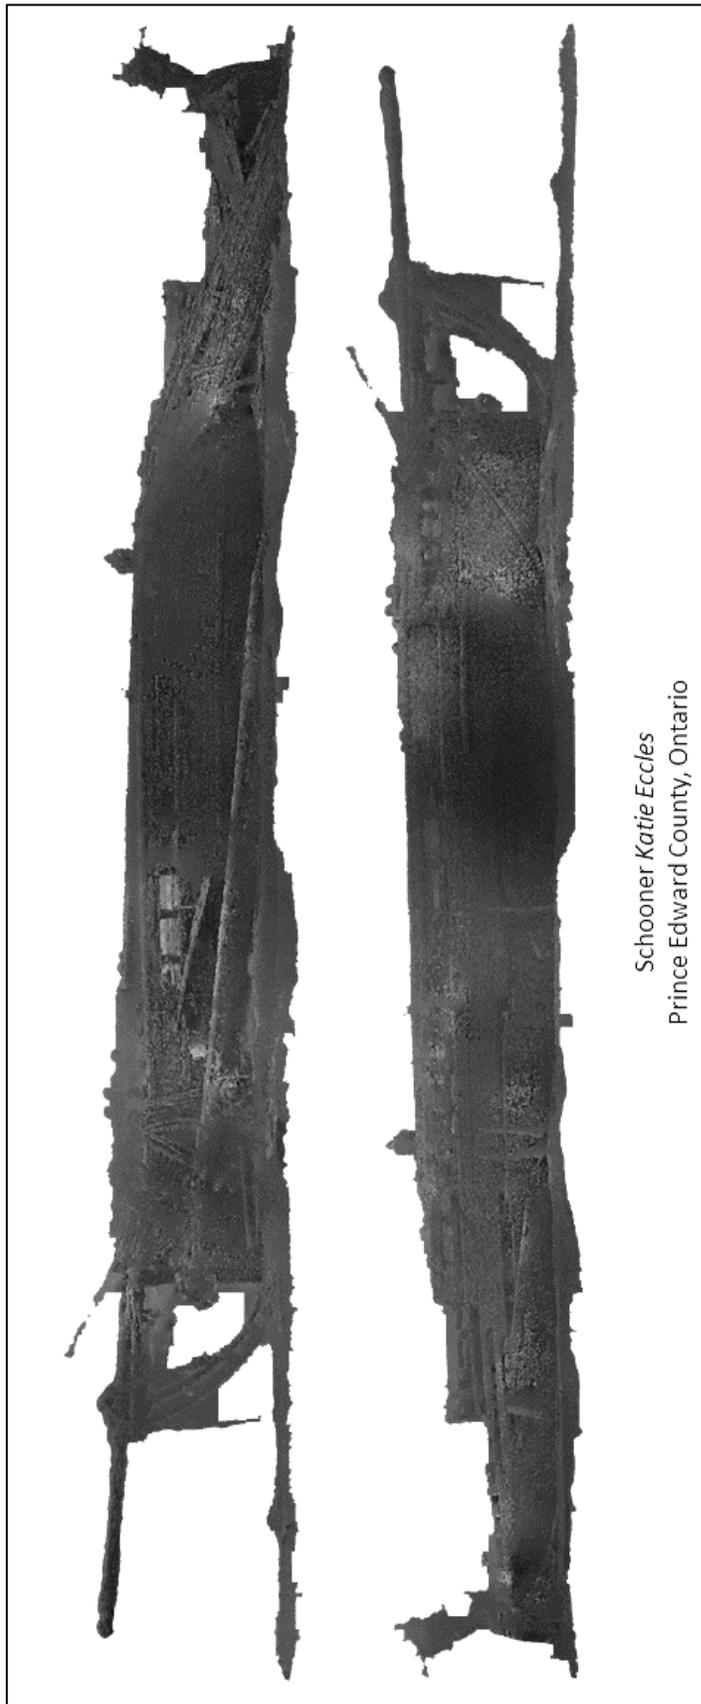
Figure 5. Elevation Views of *Katie Eccles* generated from the site orthophoto.

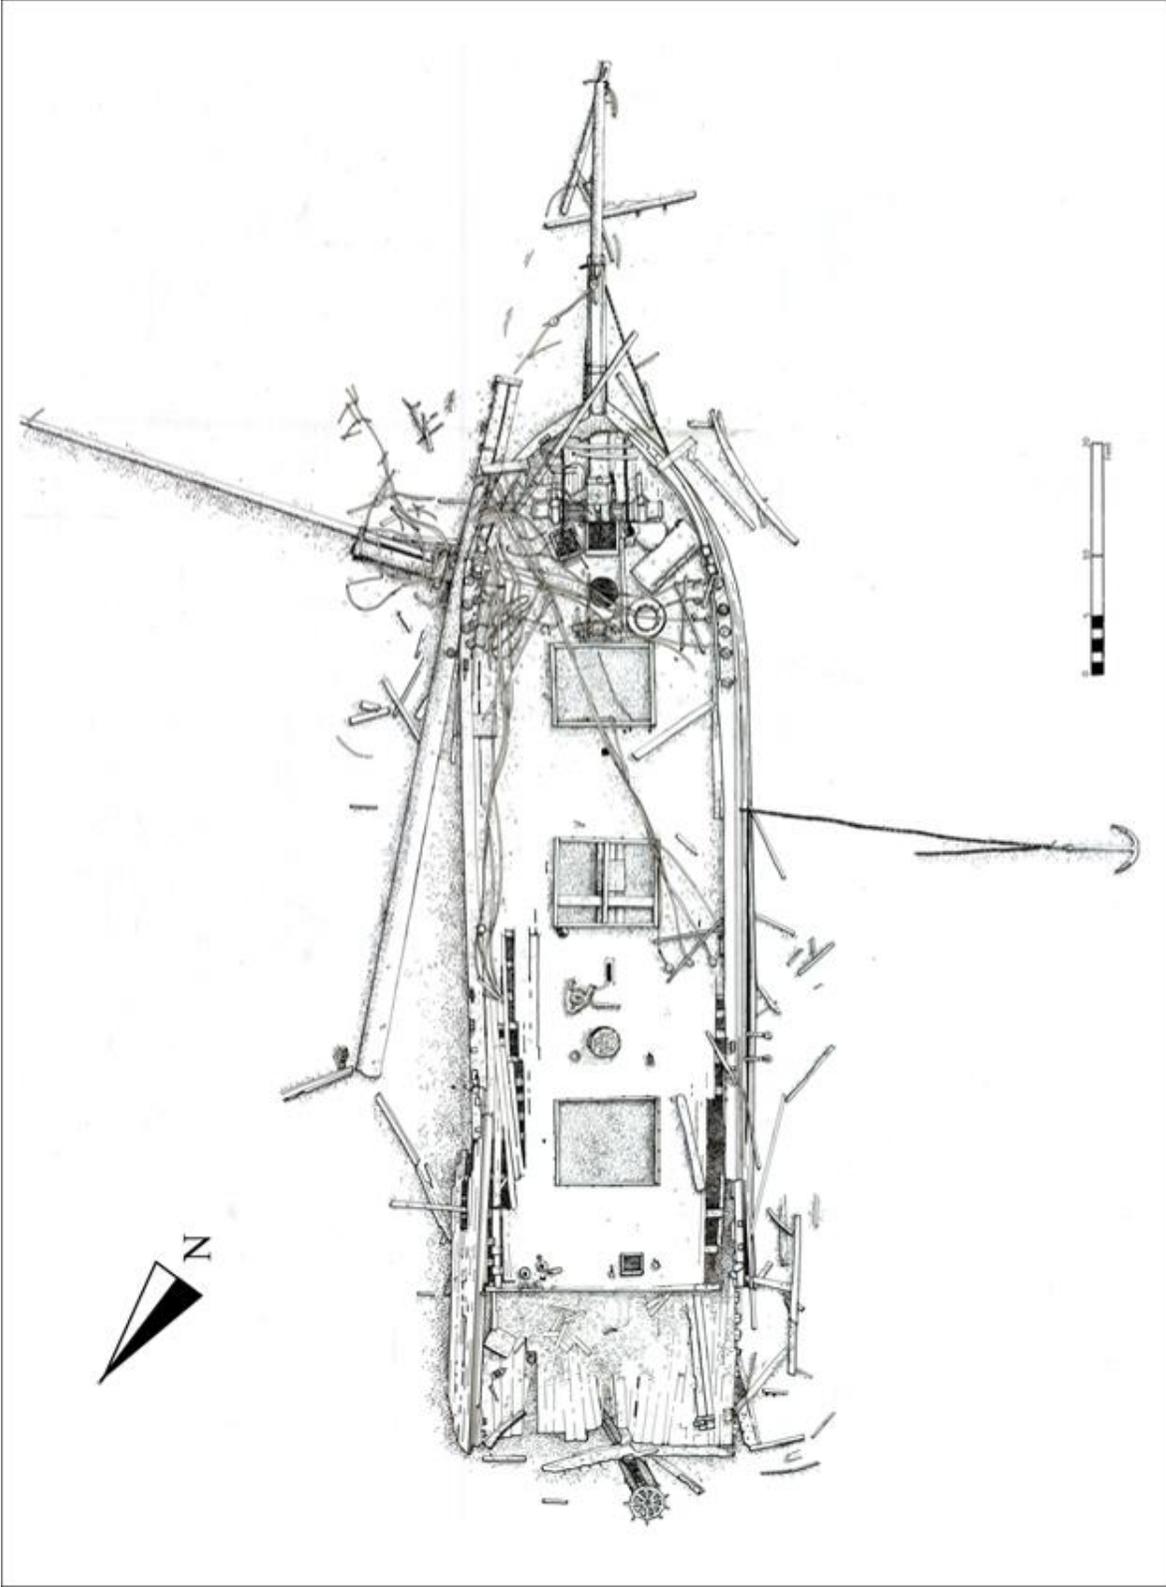
Figure 6. Site plan of the *Katie Eccles* (B. Ioset)

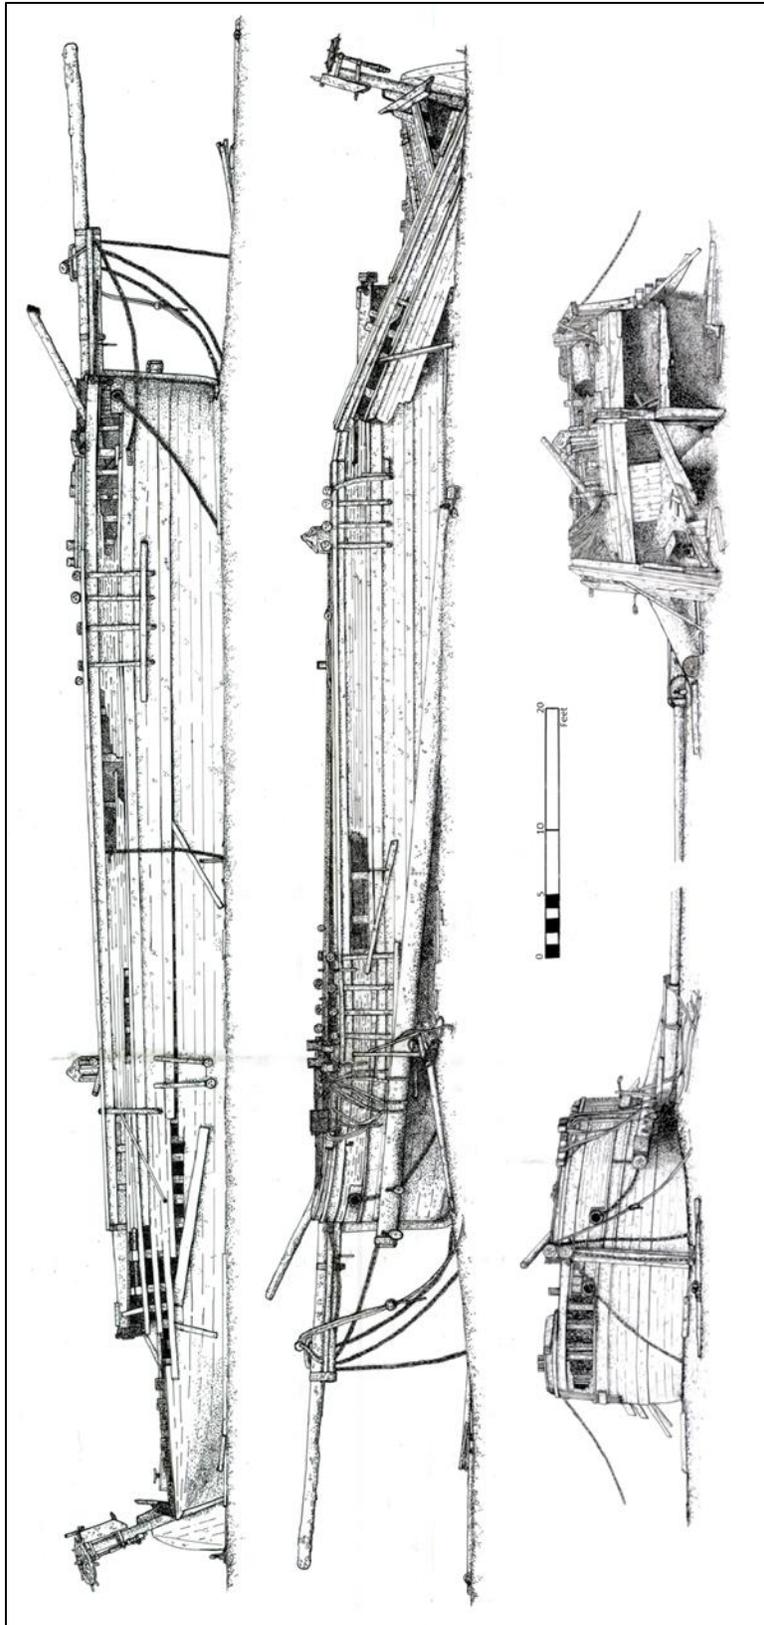
Figure 7. Site plans of the *Katie Eccles* (B. Ioset)

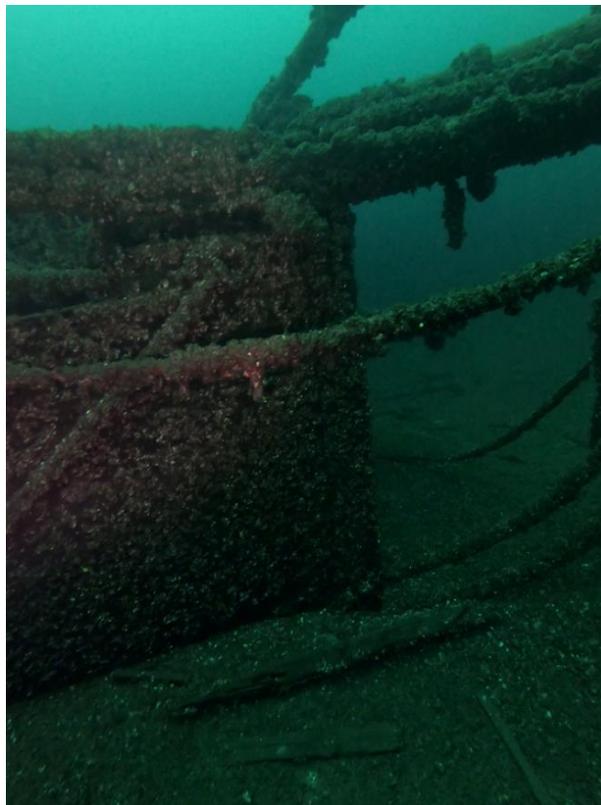
Figure 8. The starboard bow. Note the straight stem, bobstay plates and plates for the bowsprit shrouds beneath the cathead.

The keel and keelson assemblies could not be observed along most of their lengths. At the forward extremity of the keel, the upper extent of the forefoot is exposed. The forefoot's lower half is embedded in the bottom. The stem has a straight run above the forefoot of approximately 8 ft. 6 in. (2.59 m) along its forward face. The stem is nearly vertical with a 2-degree rake forward. As the hood ends of the strakes remain seated within the rabbet the overall dimensions of the stem could not be determined. The external molded dimension from the rabbet line to the forward face of the stem is approximately 1 ft. 5 in. (0.41 m) at the head of the stem, tapering to 1 ft. (0.30 m) at the foot. The stem's forward sided dimension could not be reliably measured.

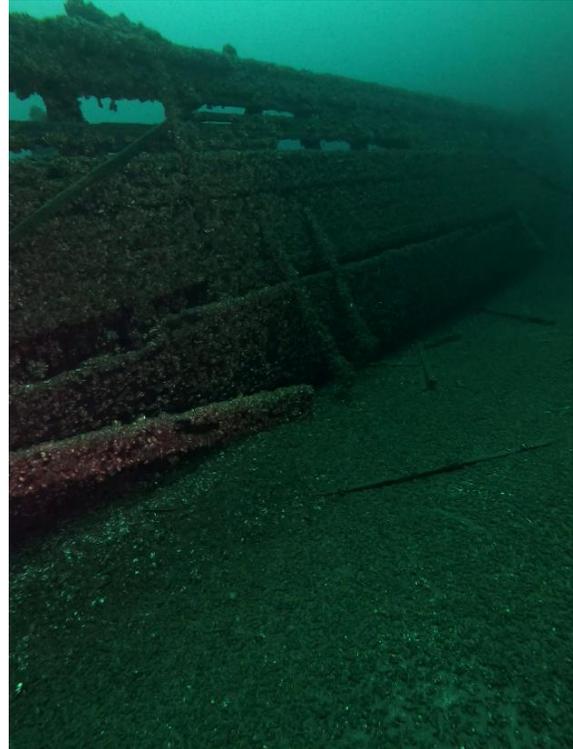
Figure 9. The disarticulated lower hull sections revealing the framing amidships and the starboard main chains.

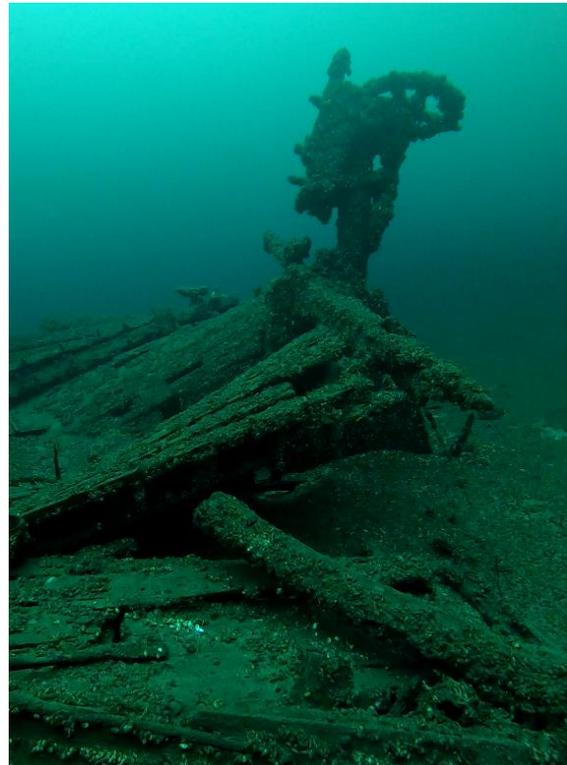
Figure 10. The stern from the starboard quarter. Note the folding davit in the foreground.

The inboard halves of the folding davits were fastened to the upper face of the chock rails. The inboard halves of the folding davits were fastened to the aft chock rails. These inboard davit timbers were 5 ft. 5 in. (1.67 m) long. A hinge is fastened to the upper face of the davit and the folding davit arm. The davit arms had an upward curving profile along their length of 4 ft. 6 in. (1.37 m). Slots for two internal sheaves are cut into the outboard end of the timber. Only the portside davit was observed on-site.

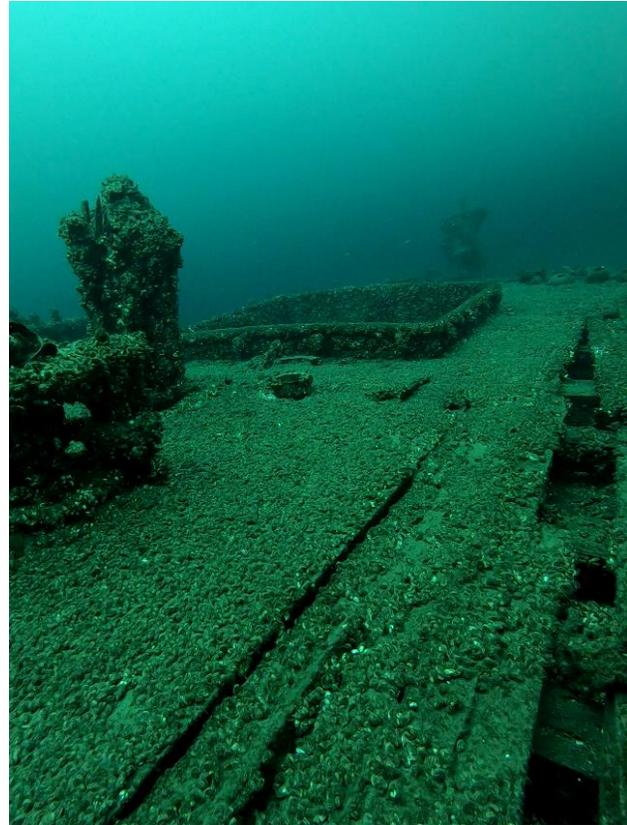
Figure 11. The deck looking aft along the port side.

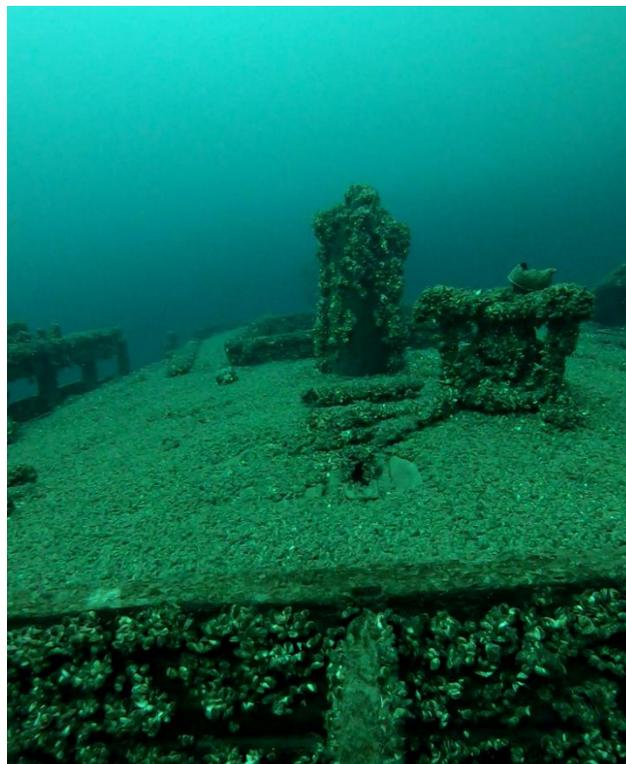
Figure 12. The centerboard pennant chock, pennant cable and centerboard winch with the mainmast looking aft

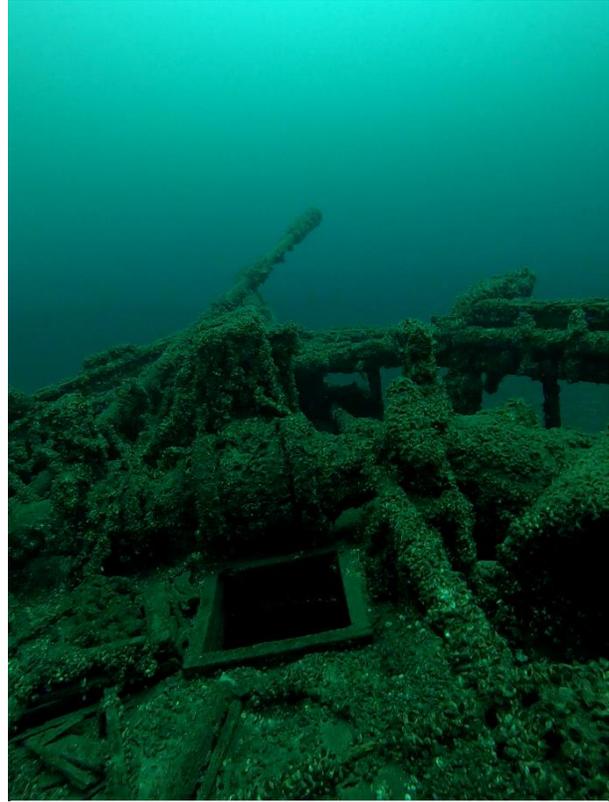
Fig.13 The foredeck with the pawl post, windlass and forecabin hatch

The pawls are mounted to the after face of the pawl post, the pawls acting on the pawl rim along the centerline of the windlass barrel. Immediately outboard of the pawl rim, centered at 10 in.

(25.4 cm) outboard of the centerline, are two purchase rims. Two purchase arms acted on the forward side of the purchase rims, pivoting on a pin in the sides of the pawl post and actuated by a rocker on the upper forward face of the pawl post. These were connected to the purchase arms by purchase links. Outboard of the purchase rim, between 1 ft. and 2 ft. 6 in. (0.30-0.76 m) outboard, were the whelps, along the length of which the diameter of the barrel tapered. Outboard of the whelps and against the inner face of the carrick bitts, between 2 ft. 6 in. and 3 ft. 4 in. (0.76-1.01 m) outboard of the centerline, were a set of cable lifters. The cable lifters have pockets for the links of the chain cable. The chain pockets could not be measured. Outboard of the carrick bitts are a set of warping ends, the ends of which are 6 ft. (1.82 m) outboard of the centerline. A chain stopper, still attached to its lanyard, lies against the after face of the pawl post atop the pawl rim.

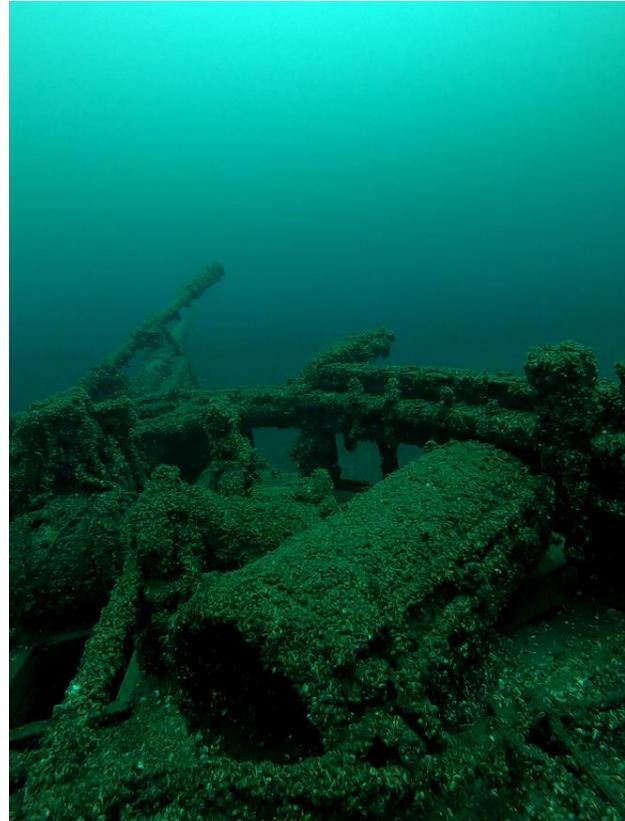
Figure 14. The vertical boiler resting on the fore deck. Note the funnel and possible steam siphon at center left.

The vertical boiler was attached to a steam engine and hoist by a steam pipe which fed into a valve chest and single-cylinder on the starboard forward side of the winch. The piston arm was linked by a pitman arm to a flywheel on the starboard side of the winch assembly. The winch was secured by a base formed by two fore-and-aft beams secured to the deck. The flywheel was attached to a small spur wheel by a connecting rod, which acted presumably on the main spur wheel on the main barrel. This main spur wheel is situated inboard of the starboard bearings of the main barrel. This main spur wheel is situated inboard of the starboard bearings of the main barrel. Outboard of both bearings are a pair of warping ends that extend beyond the frame.

What appears to be steam pipe runs forward from near the valve chest to what is likely a steam siphon situated on deck 14 ft. (4.26 m) along the baseline, immediately aft of the starboard carrick bitt. The details of this feature are obscured by dreissenid fouling, yet its connection to the boiler and the absence of bilge pumps elsewhere support this identification.

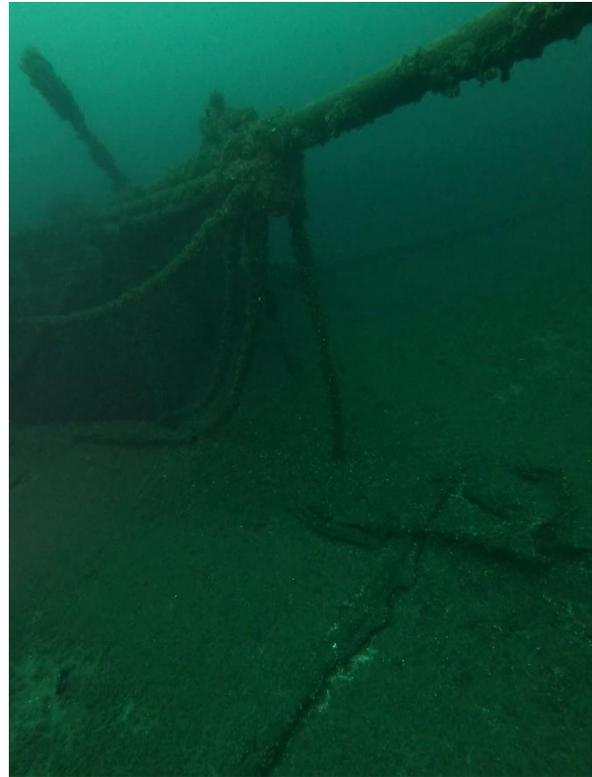
Figure 15. The bowsprit and jib boom of *Katie Eccles* with the bobstays, starboard and port bowsprit guys, jumbo jib stay and jumbo jib boom. Note the spreader and martingale spar.

The outboard length of the bowsprit, forward of the chock rails is approximately 12 ft. (3.65 m), making the overall length of the bowsprit approximately 19 ft. (5.79 m). The outboard length has a flat upper face, formed by the fastening of two battens to either side of the bowsprit, or by a plank fastened to a flat upper face of the bowsprit, terminating just before the iron bowsprit cap band.

The jib boom has an overall preserved length of 28 ft. 6 in. (8.68 m), with a doubling of 12 ft. 6 in. (3.81 m). The jib boom was secured by an iron band 3 ft. 6 in. (1.06 m) forward of the chock rails, and by the bowsprit cap. The outermost section of the jib boom is broken off at approximately the attachment of the inner jib stay and lies beneath the jib boom. An iron band is secured just below the head of the jib boom, to which are shackled the jib boom guys on its lower face.

The spreader and martingale spars rest on the bottom beneath the bowsprit cap and jib boom with the martingale spar overlying the spreader (Fig.15). A saddle fitted to the forward face of the spreader rested against the underside of the jib boom when the spar was lashed in place. Two fairleads hang from staples on the starboard arm of the spreader and, though not observed, are presumed present on the port side as well.

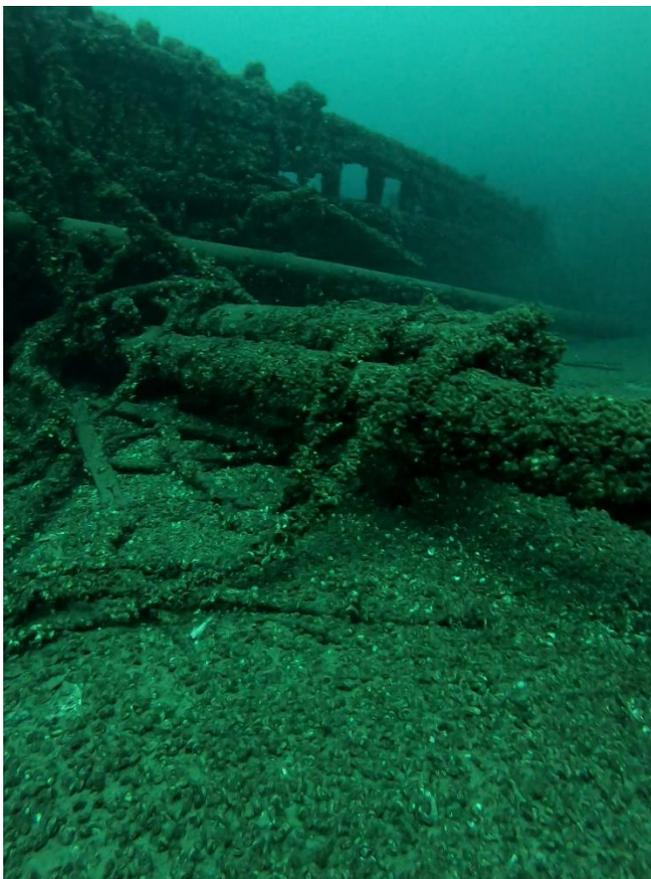
Figure 16. The foremast doubling with the remains of the cross trees and trestletrees and the fid in place.

While the lower foremast beneath the hounds is unaccounted for, the doubling of the foremast and the foretopmast rest on the bottom with the hounds resting against the hull at the port forechains and the masthead extending outward. The foremast doubling, partially obscured by the mainmast which overlies it near its lower end, has an approximate length of 9 ft. 6 in. (2.89

m) with an octagonal cross-section formed by the chamfering of the corners of the lower masthead.

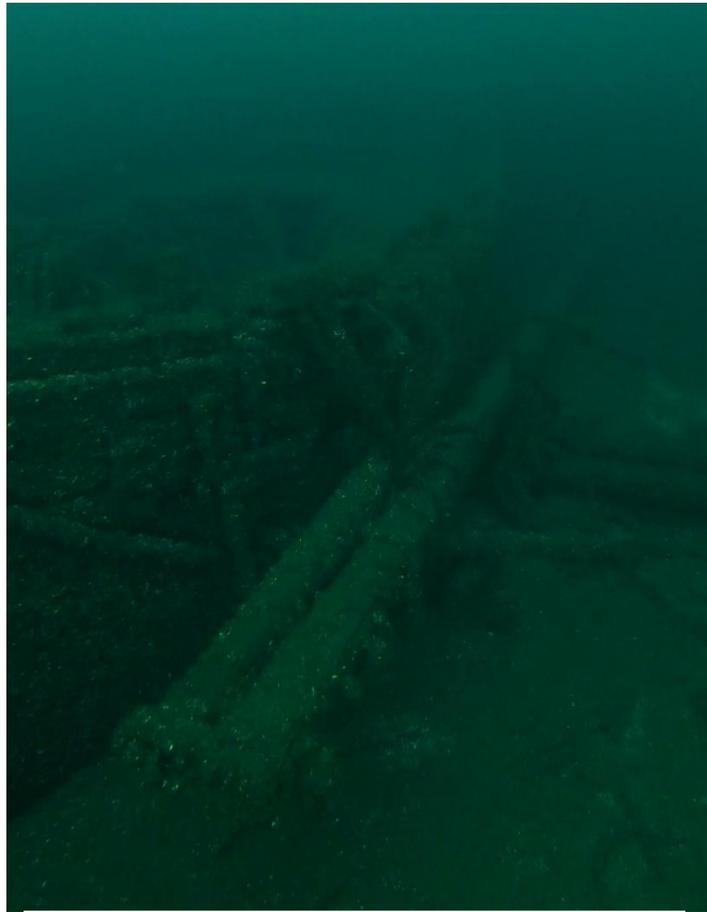
Figure 17. The mainmast along the starboard side overlying the foremast doubling.

The main portion of the mainmast lies just off of and parallel to the port side, overlying the hounds of the foremast. The preserved length of this section of the lower mainmast, measured to the mast cap is 63.5 ft. (19.35 m) with a doubling of approximately 10.5 ft. (3.20 m). Therefore,

the lower mainmast had a height of approximately 68 ft. (20.72 m) above the deck, with the hounds 57.5 ft. (17.52 m) above the deck. The approximate diameter at the masthead is approximately 1 ft. 1 ½ in. (0.34 m). The mainmast trestletrees are detached and the loops of three of the pairs of shrouds have slid down the mast to the hounds. The iron hounds are approximately 4 ft. 3 in. (1.29 m) long, with widths of 1 ft. (0.30 m) at the top, tapering downward along their length. The main topmast is broken off even with the top of the mast cap.
